## **FERRING VILLAGE**

### **EXTRACT ON DRAINAGE ONLY FROM THE ROAD CONDITION SURVEY & DRAINAGE REPORT**

**Ferring Residents  
& Owners Association**

**HIGHWAY ASSOCIATES  
Road Maintenance Consultants  
*In association with  
Gerald Tobias***

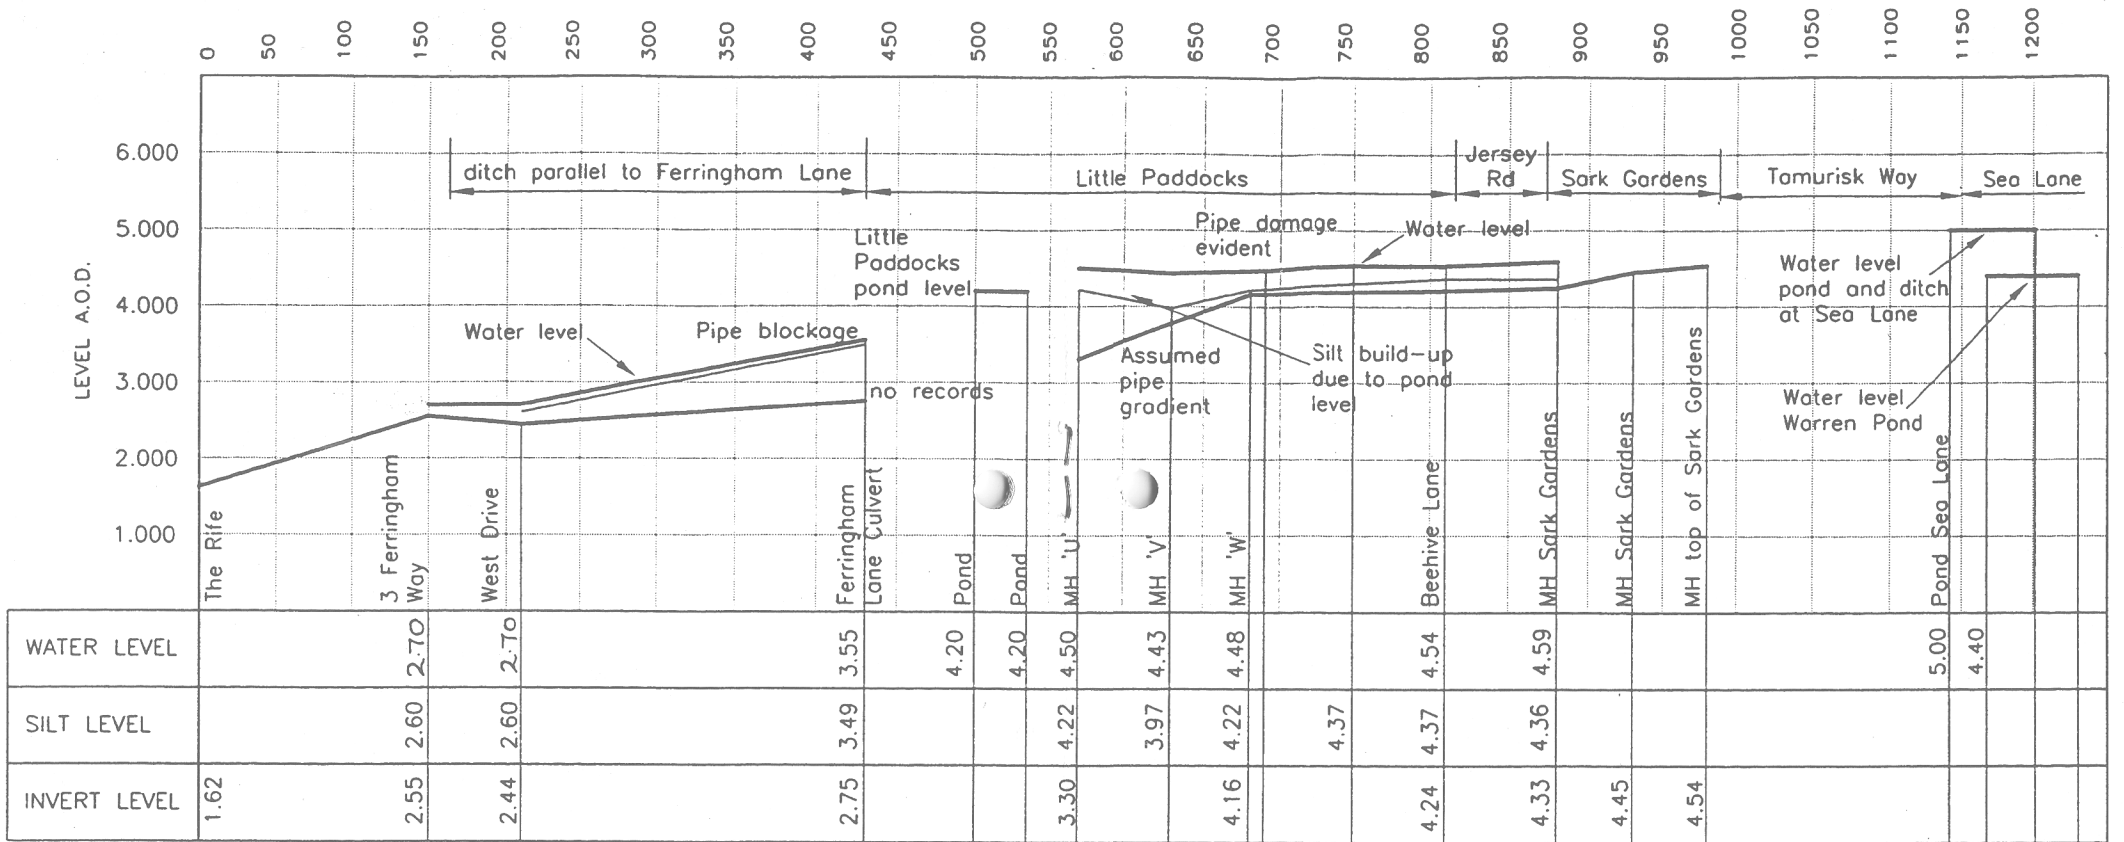
*DRAINAGE LONG SECTION FROM THE RIFE -  
 FERRINGHAM LANE - SARK GARDENS - SEA LANE  
 SCALE 1:100 VERTICAL, 1:500 HORIZONTAL*

Invert levels of this drain run on the east side of Jersey Road are approximately 5.3 -5.4 m. AOD. (Above Ordinance Datum)

At the time of the survey, these ditches were dry as expected, as the water level in Sark Gardens was 4.6m. AOD.

The water level in the pond at Warren Road was 4.4 m. AOD, indicating that water would only enter the ditch in Jersey Road when the pond overspilt as the ground level

around the pond was 5.4 m. AOD.

Sea Lane,	5.0m.AOD
Sark Gardens,	4.6m.AOD
Warren Pond,	4.4m.AOD
Pond level in Little Paddocks	4.2m.AOD

- 2.6 There was however, evidence that at least an overflow outfall was provided using the pipe run through Little Paddocks Way to Little Paddock pond. The long-section in Appendix D shows the relative levels of this connection albeit the information obtained in Little Paddocks is only provisional, as all manholes were full of silt.
