LB LITTLE PADDOCKS WAY LG15 DDP

17/10/2016

Engineers Report

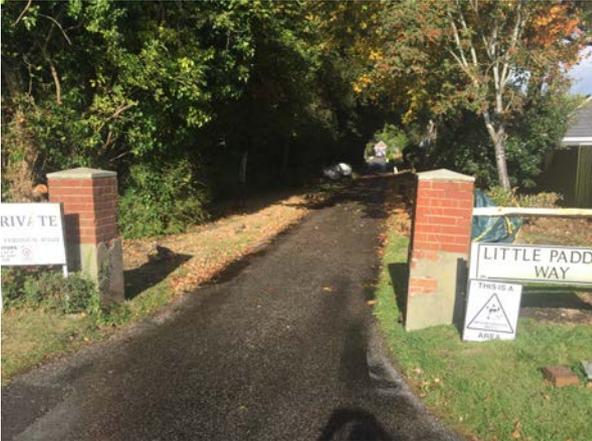
Unable to complete the full survey due to lines requiring heavy cleaning, there is a heavy build up of silt in the lines. Also the lines may need root cutting due to the trees around the area of CP02 and outfall. Access to the site will tight for a combo lorry, This will completely close the road so the residents will need to be informed of times if the cleaning is to go ahead. Access to CP01 outside Oak Lodge has Two brick pillars which are 2.70mtrs wide.

ACCESS TO CP01 2.70MTRS WIDE

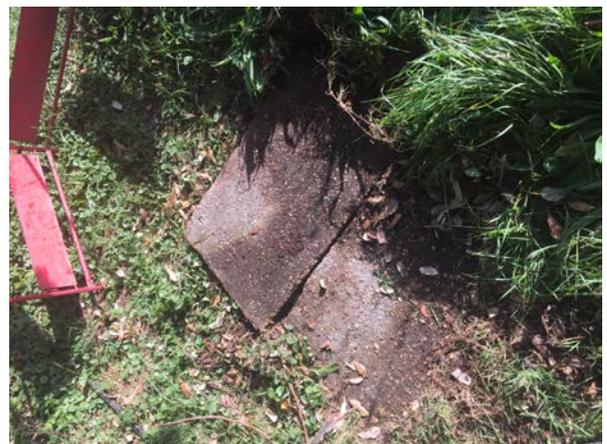
CP02 CONCRETE SLABS

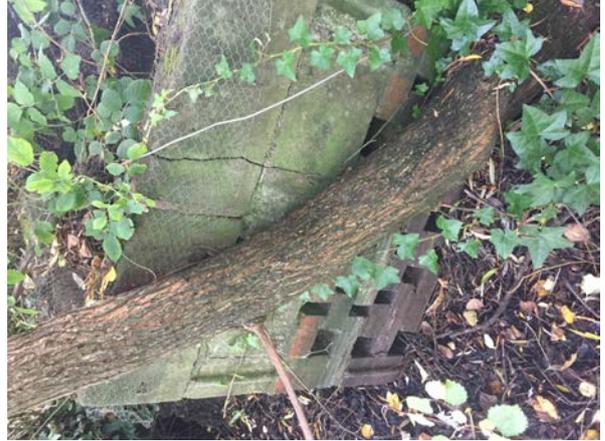
FILTER HOLES FOR OUTFALL CHAMBER

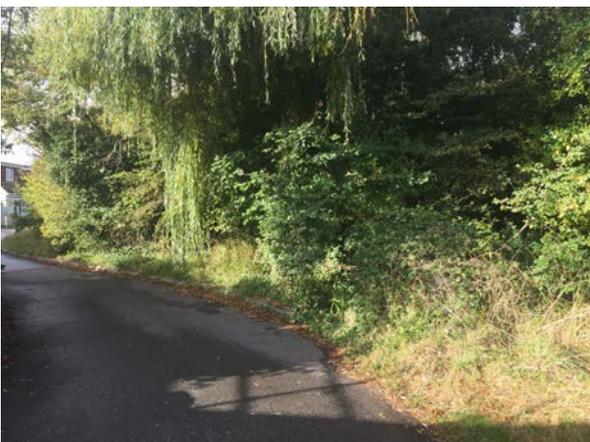
OUTFALL CHAMBER THROUGH TREES

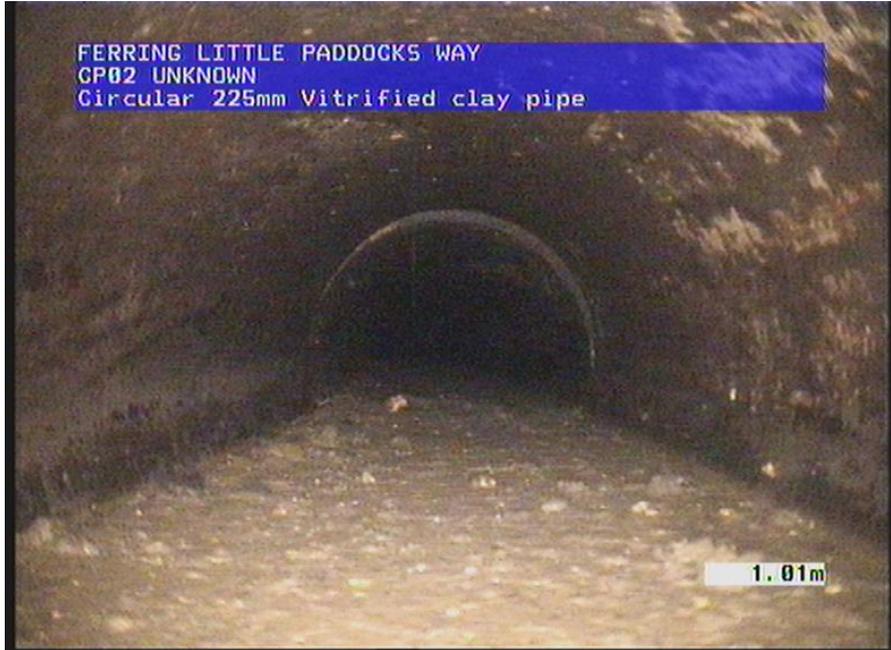
Section	Pipe Ref	Grade	Description
1	CP02X	4	Settled deposits, fine, 20% cross-sectional area loss, Finish
2	CP01X	4	Multiple defects
3	CP03X	4	Settled deposits, fine, 30% cross-sectional area loss
3	CP03X	5	Other obstacles, other from 12 o'clock to 12 o'clock, 100% cross-sectional area loss

<table><tr> <td style="width: 10%;">0.00</td> <td style="width: 10%;">CP</td> <td style="width: 5%;">CP</td> <td style="width: 45%;">Start node type, catchpit, reference number: CP02</td> <td style="width: 10%;">00:00:00</td> <td style="width: 10%;"></td> <td style="width: 10%;">0</td> </tr><tr> <td>1.01</td> <td>F01</td> <td>DES</td> <td>Settled deposits, fine, 20% cross-sectional area loss, Finish</td> <td>00:00:53</td> <td></td> <td>4</td> </tr></table>

CP02X_0d71d605-ea92-44b4-82a8-0491365f6f5e_20161017_103648_700.jpg, 00:00:53,
1.01m
Settled deposits, fine, 20% cross-sectional area loss, Finish

Comment:
 Recommendation: **REQUIRES CLEANING**

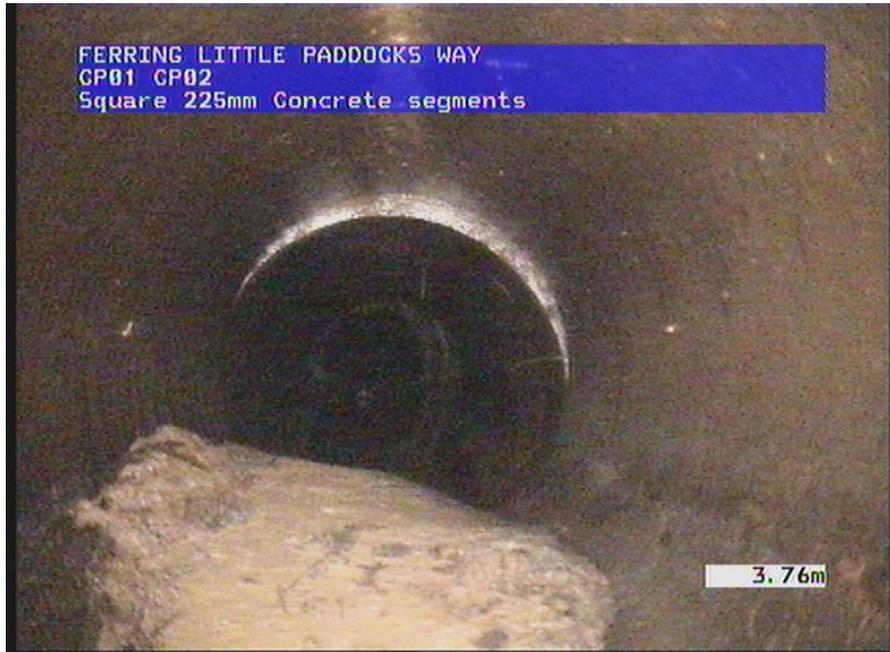
CP01X_25d24d22-e1f7-4d31-b483-7d06f462cdca_20161017_114233_007.jpg, 00:00:56,
 3.76m
 Settled deposits, coarse, 20% cross-sectional area loss

Comment:
 Recommendation: **REQUIRES CLEANING**

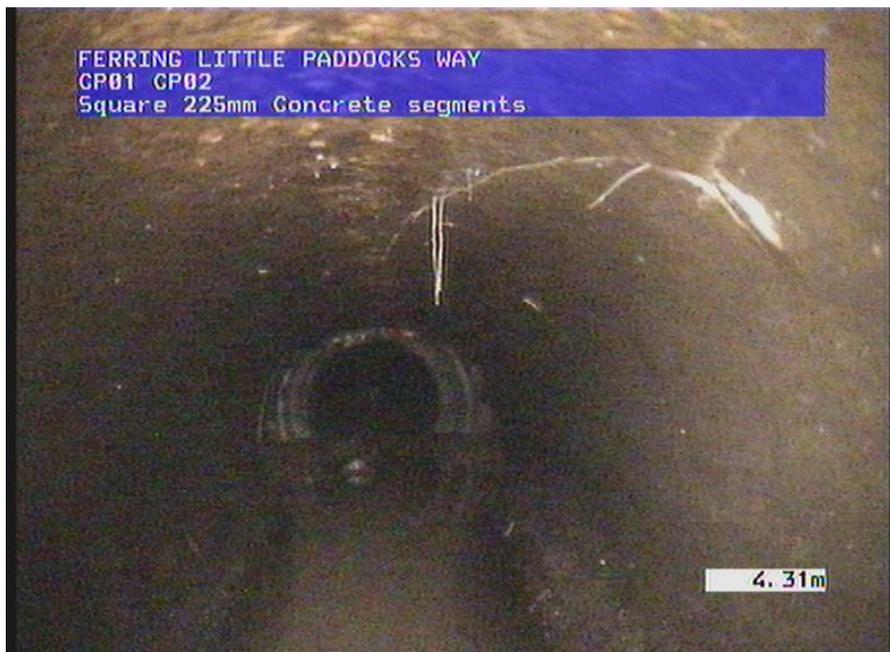
Section	Pipe Ref	Grade	Description
2	CP01X	3	Fracture, longitudinal at 01 o'clock

Grade 3: Best practice suggests consideration should be given to repairs in the medium term.

CP01X_44847968-2ad8-411f-bb9f-13bfcc569dfd_20161017_114258_902.jpg, 00:01:07,
 4.31m
 Fracture, longitudinal at 01 o'clock

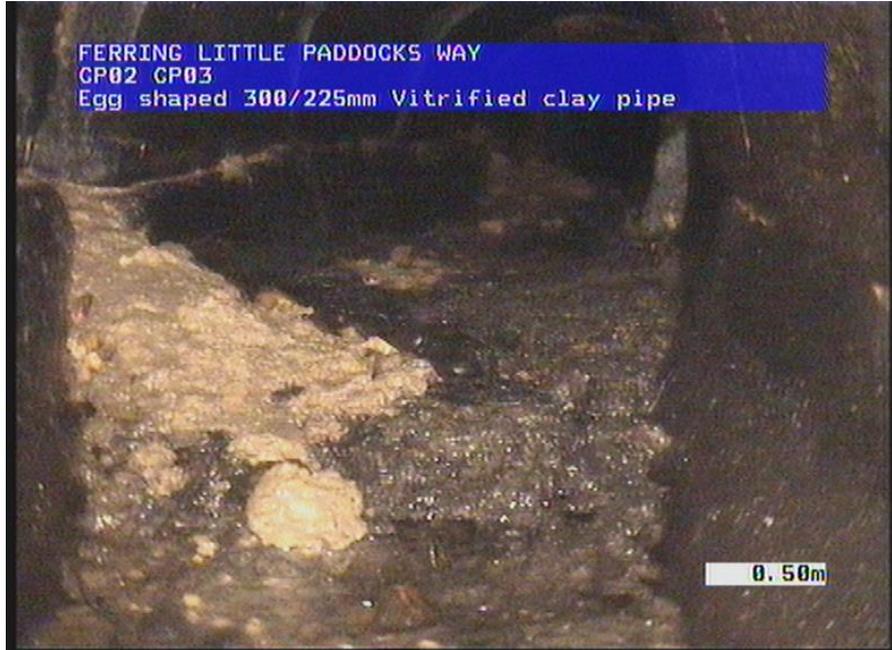
1:802	Position m	Code	Observation	MPEG	Photo	Grade
Depth: 1.30						
CP02						
	0.00	CP	Start node type, catchpit, reference number: CP02	00:00:00		0
	0.00	WL	Water level, 0% of the vertical dimension	00:00:00		0
	0.50	DES	Settled deposits, fine, 30% cross-sectional area loss	00:00:07		4
	0.50	SA	Survey abandoned / DEBRIS SILT	00:00:16		0
	95.00		End of pipe			0
CP03						
Depth: 1.50

CP03X_f6453f28-60fd-4640-8a96-e31e7be0577e_20161017_113346_084.jpg, 00:00:07,
0.50m
Settled deposits, fine, 30% cross-sectional area loss

Comment:
 Recommendation: **REQUIRES CLEANING**

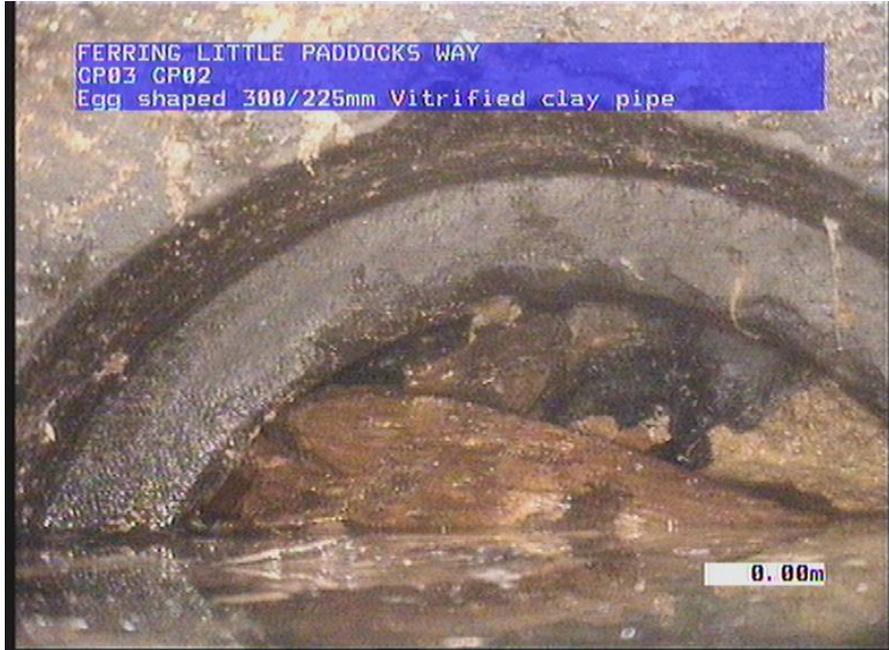
Grade 5: Best practice suggests that this pipe is at a high risk of backing up or causing flooding.

1:802	Position m	Code	Observation	MPEG	Photo	Grade
Depth: 1.50						
CP03						
	0.00	CP	Start node type, catchpit, reference number: CP03	00:00:00		0
	0.00	WL	Water level, 50% of the vertical dimension	00:00:00		0
	0.00	OBZ	Other obstacles, other from 12 o'clock to 12 o'clock, 100% cross-sectional area loss	00:00:13		5
	0.00	SA	Survey abandoned / OBSTRUCTION / DEBRIS BUILD UP	00:00:16		0
	95.00		End of pipe			0
CP02						
Depth: 1.30

CP03X_84484d99-e6fa-4085-b8ef-851152bdbb1_20161017_115627_512.jpg, 00:00:13,
0.00m
Other obstacles, other from 12 o'clock to 12 o'clock, 100% cross-sectional area loss

Comment:
 Recommendation: **REQUIRES CLEANING**
